# Manhole Inspection Summary

Manhole # S37AA1036MH

**Location** Address: **3400 OLD YORK RD**

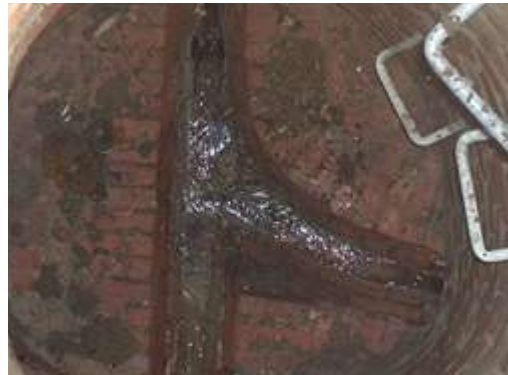
Top View

Evidence of surcharge - Bench debris.

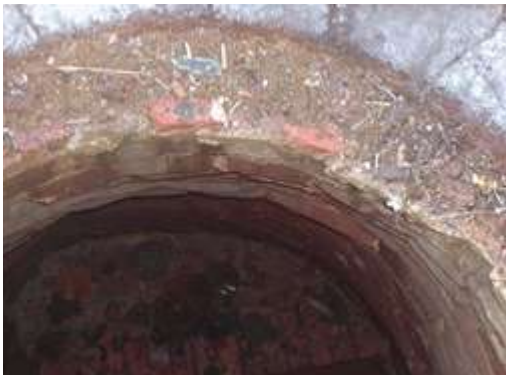
Defect

Frame offset. Adjustment deterioration and infiltration. Barrel infiltration.

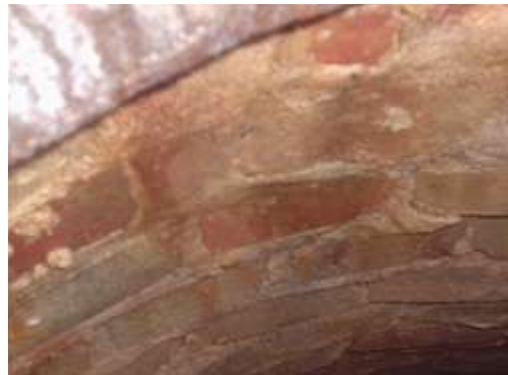
Defect

Adjustment infiltration.

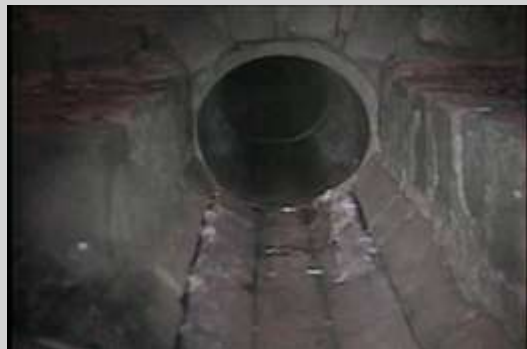
8 in. Circular Gravity Sewer

Channel deterioration.
